SAFETY BULLETIN

Incident
#01-2025

Securing of vessel doors whilst underway

ISSUE DATE: 04 April 2025

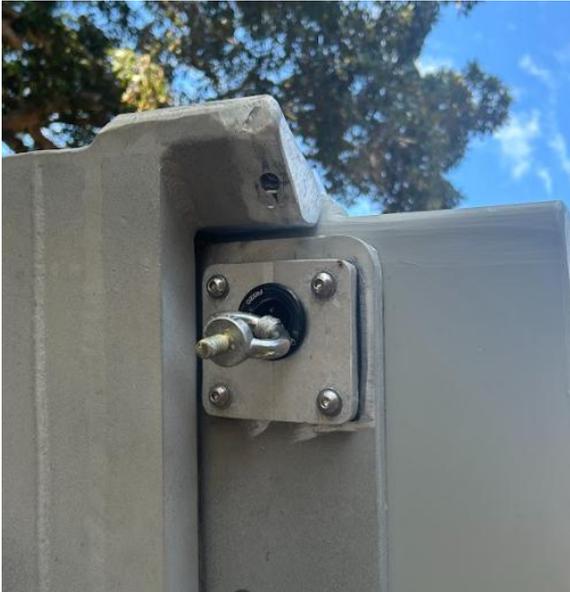
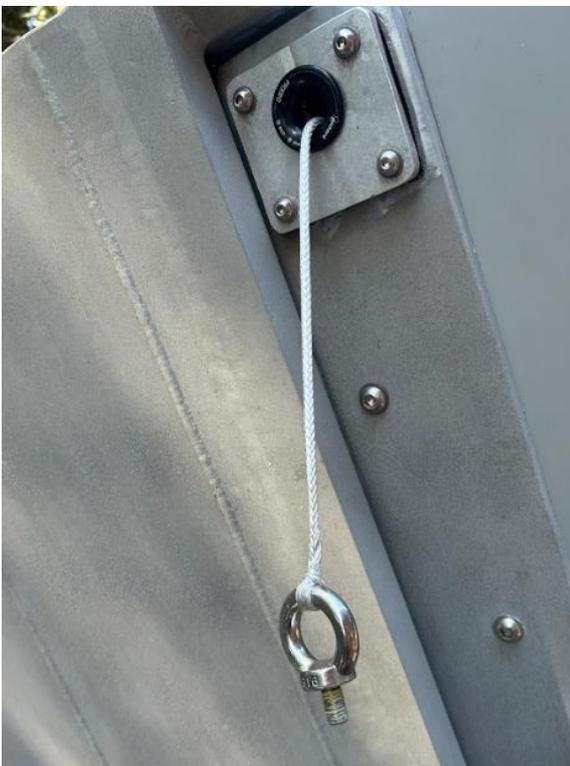
Issue: *Eye bolt coming free from door fitting, causing the bow door to fall open, the likelihood of this occurrence is possible and consequences may be extreme when underway at speed.*

Retaining eye bolt has been pulled out of the thread from the door. This bolt is attached to the Spectra line on the winch.

Fatigue of use and over tensioning of the winch may have been factors in the failure of this fitting.

- 1. Check all opening fixtures and fittings to ensure the function properly*
- 2. Check securing points are not deteriorated or loose.*
- 3. Secure all retaining points, cam locks or security straps correctly.*
- 4. Monitor fixtures to ensure they do not vibrate loose.*
- 5. Conduct regular inspections of retaining equipment.*
- 6. Do not presume prior knowledge.*
- 7. Clean and maintain equipment.*

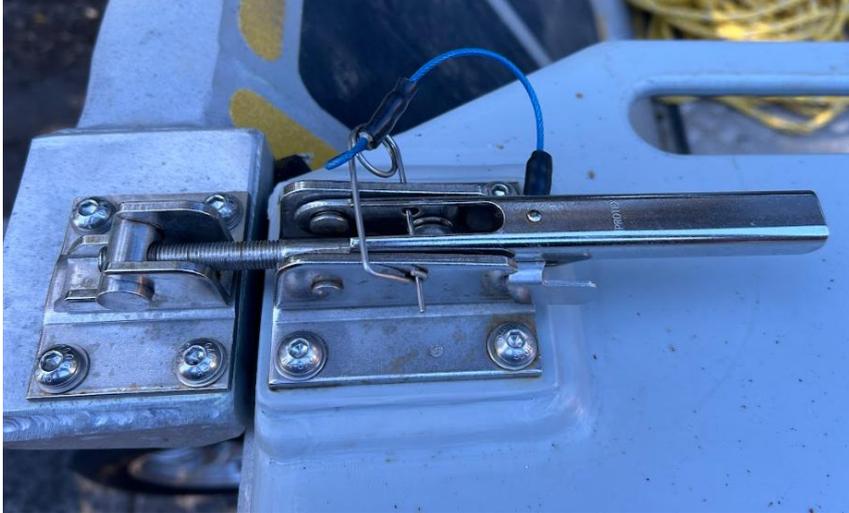
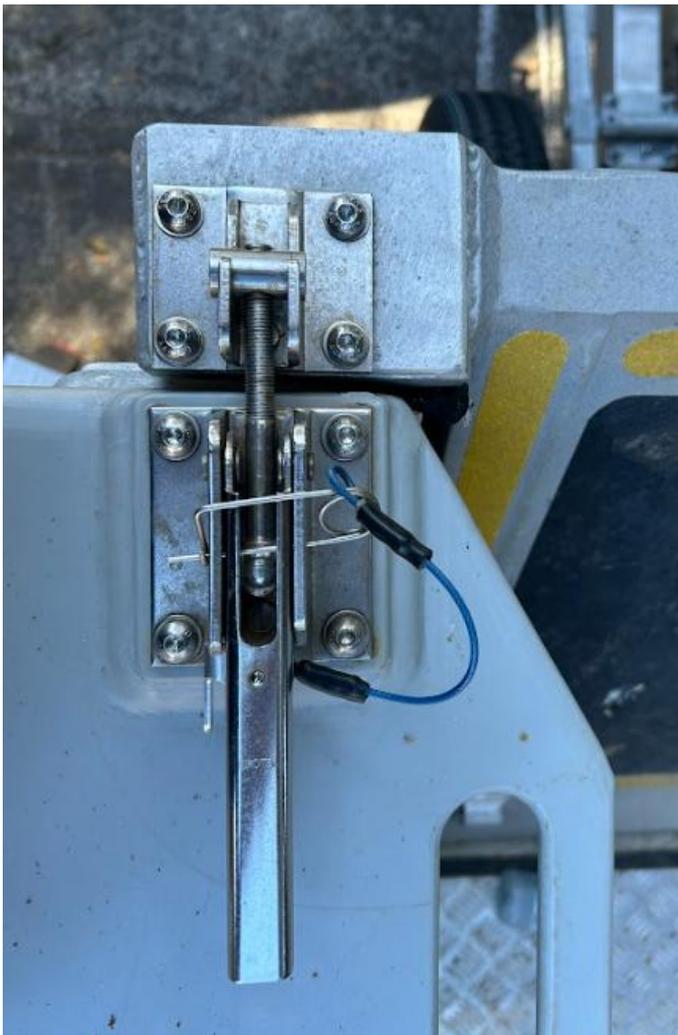
Example of the cam style lock
in fully secured position with
security clip in place.

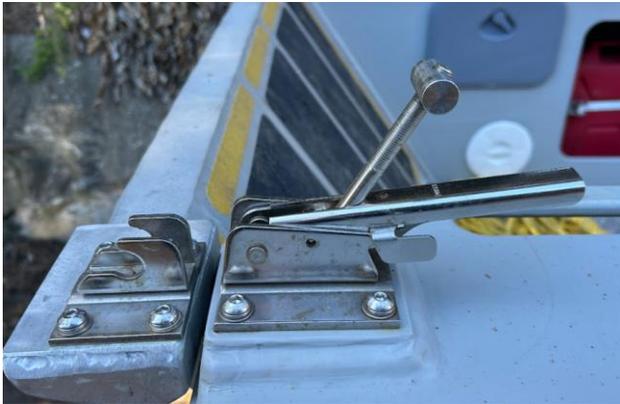
Door latch in open position

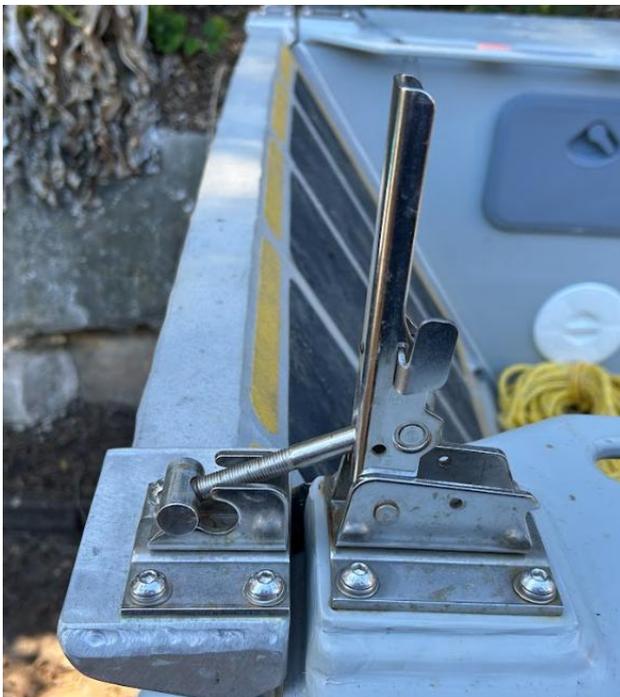
Door latch released and
not secure.

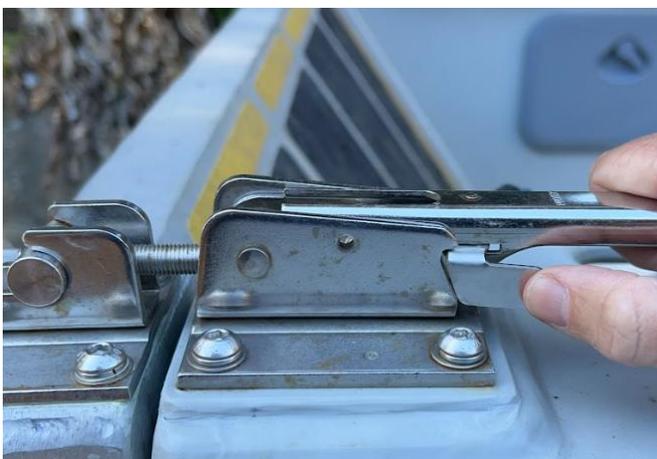
Cam release lock.

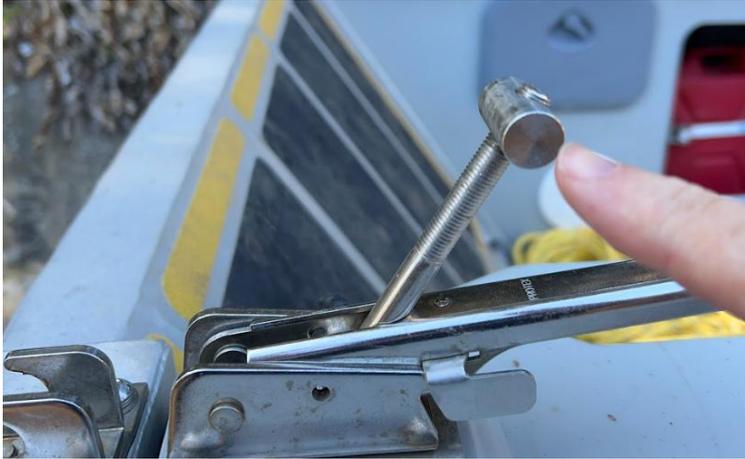
Adjustable head for cam lock
reach to retaining claws.
